NexxZr⁺ white
monolithic
by Dr. Gonzalo Perea

Sagemax experience

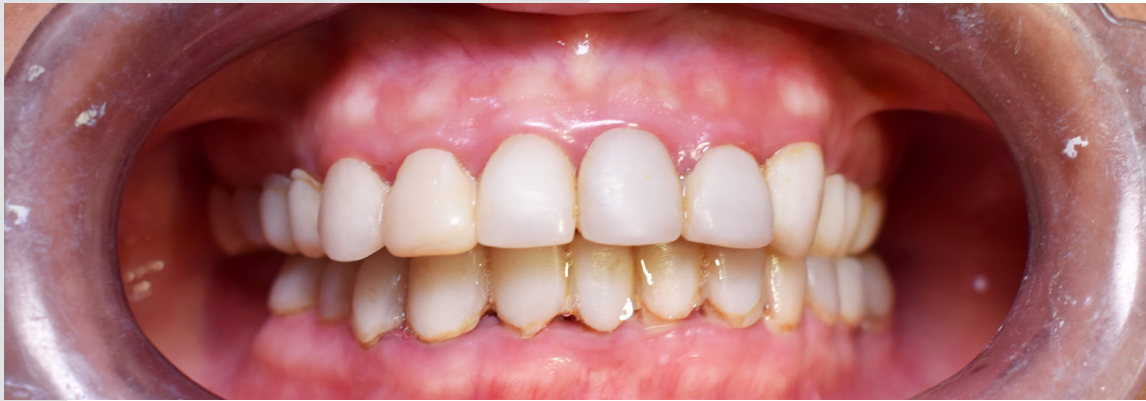
The patient came to us with a faulty treatment. The inserted acrylic crowns had a poor anatomical fit, resulting in leaking margins, tartar, caries and severe halitosis.

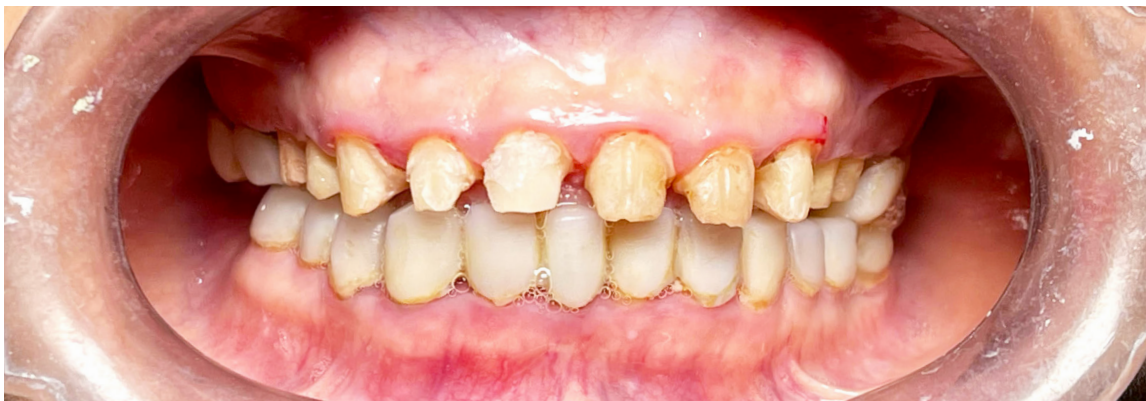
In the first step, the acrylic crowns were removed.

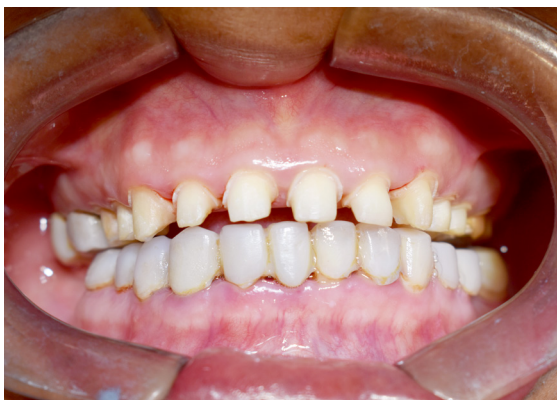
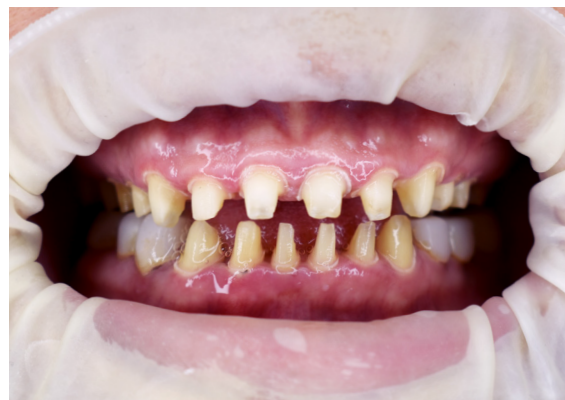
Tartar and discoloration were then removed, and the tooth surfaces were prepared, polished and smoothed.

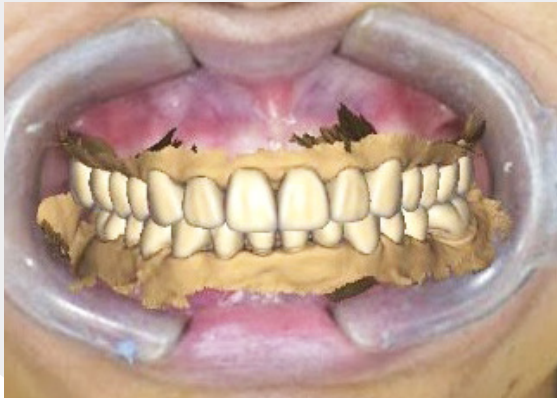
Digital design in exocad (Co. exocad) after digital scanning.

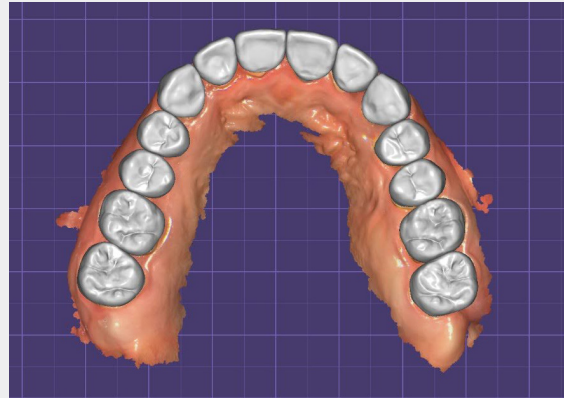
Occlusal view of the 3D design of the anatomically designed crowns in the upper jaw.

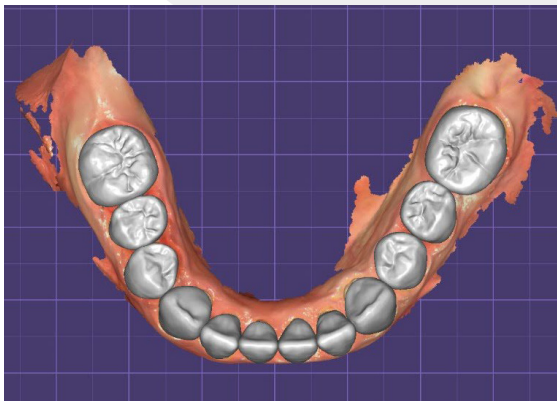
Occlusal view of the 3D design of the anatomically designed crowns in the lower jaw.

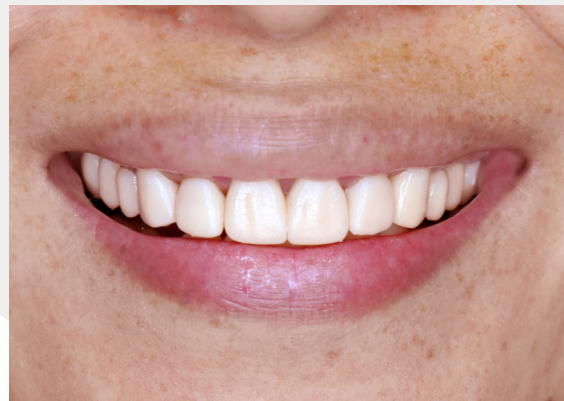
Try-in and design check with milled acrylic crowns.

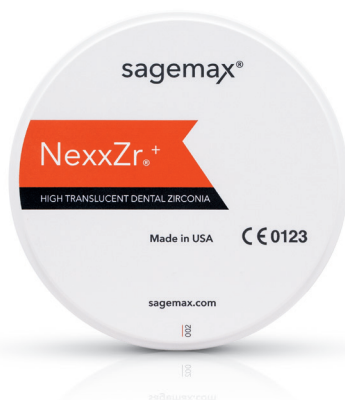
The crowns were fabricated from NexxZr+ white zirconia and subsequently stained and glazed with IPS Ivoclar (Co. Ivoclar).

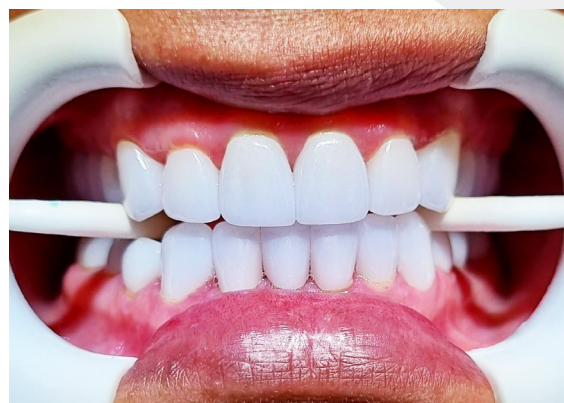
Cementation of the restorations in the mouth.

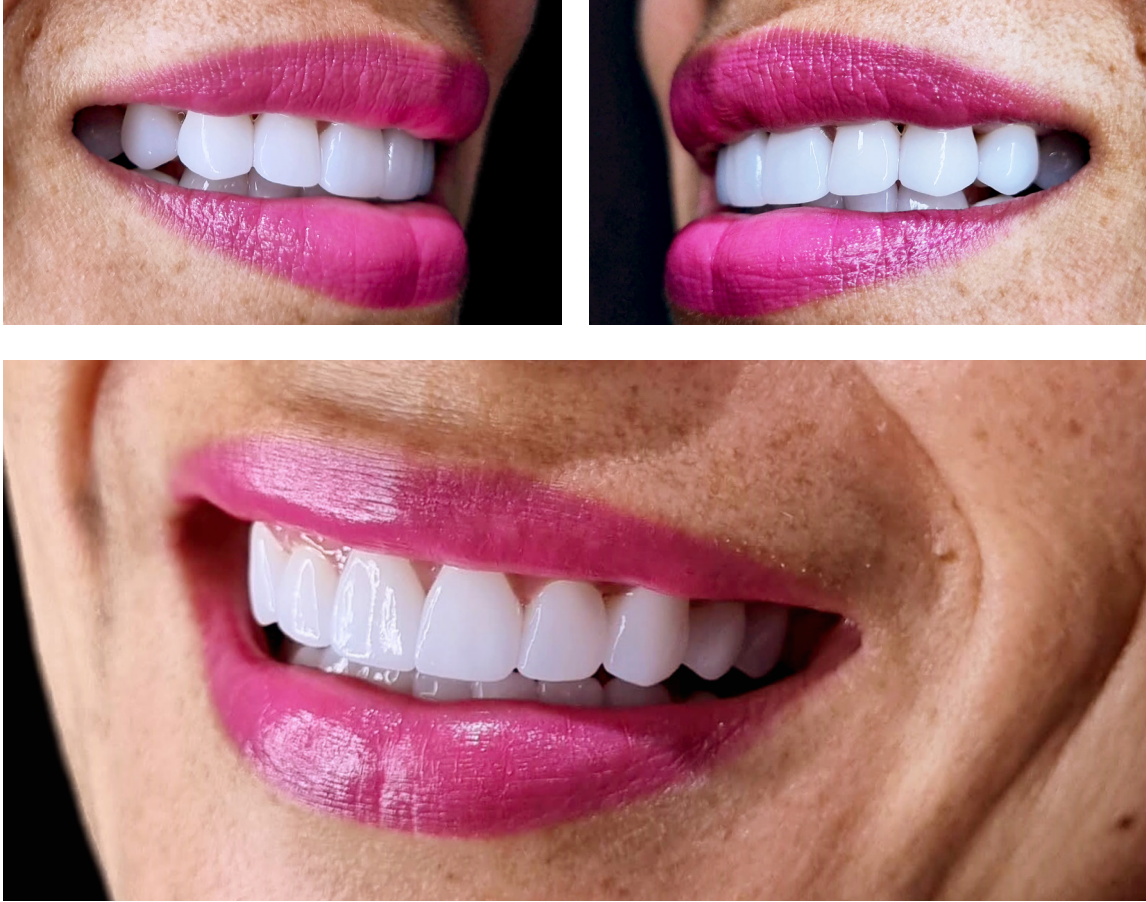
The final result of the stained and glazed NexxZr⁺ white crowns after cementation. A smile that enchants.
