Sagemax experience

Initial situation and preparation

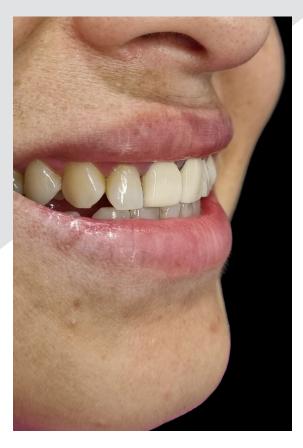
33-year-old female patient with diminished self-esteem would like to have the leaking, poorly designed metal-ceramic crowns replaced with all-ceramic crowns. Determination of the initial colorimetry on tooth 12.

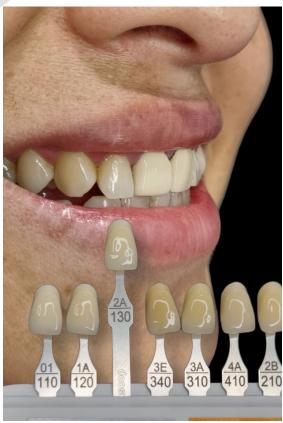
Initial situation after removal of the metal-ceramic crowns. Ready for gingival reshaping treatment, endodontics and fiberglass post placement in tooth 11 and 21.

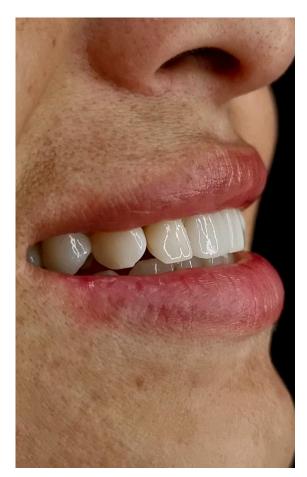
The final result of the monolithic NexxZr T Multi crowns after cementation. Determination of final colorimetry.
